Manhole Inspection Summary

Manhole # S47I__058MH

Insp Date: **4/22/08 10:23 AM**

Location Address: **decker ct**

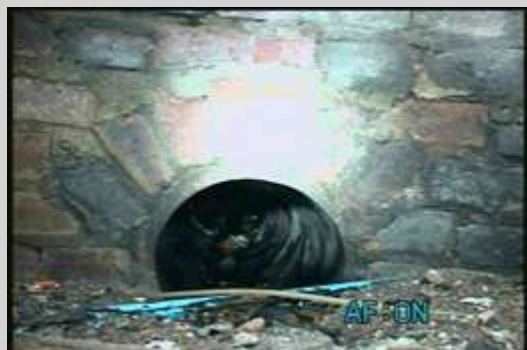
12 O'Clock Outflow

8 in. Circular Gravity Sewer
Pipe Out @ 12 O'Clock

Infiltration: **None** Pipe Seal Cond: **Unknown**
